This bulletin covers the Valve Position Update for the AXP device with firmware version 1.12.

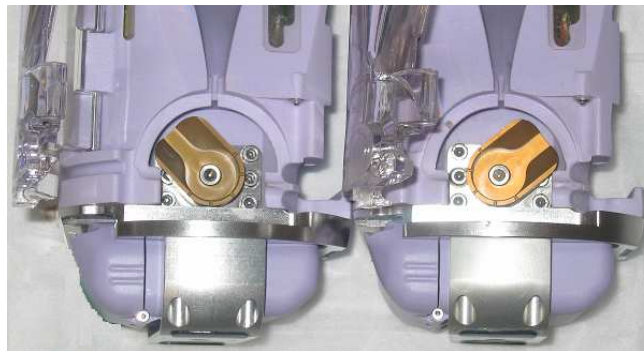
A Valve Position Update has been introduced as a product enhancement; this will not affect the customer's current operation of the AXP device. This update will improve the AXP performance and accuracy. Currently, the valve ends at the 45 degree position (i.e., pointing to 10 o'clock) after spin completion. The Valve Position Update will change the valve position after spin completion to the 142 degree position (i.e., pointing to 2 o'clock). After the device is reset, the valve will return to the 45 degree position.

45 degrees
CURRENT

142 degrees
NEW UPDATE

Devices with the new style bag carrier will have V1.12 firmware. The device firmware version is also listed on several different types of reports. If the device has V1.12 firmware, then request the Valve Position Update by emailing support@thermogenesis.com. Please provide the serial numbers of your AXP devices in your email. THERMOGENESIS CORP. Technical Service will then email you the Valve Position Update Utility with loading instructions.

For AXP devices that have firmware that is less than V1.12, please contact your authorized service provider to arrange to have your device updated.
